# Rapport d'enquête technique Marine investigation report

**INCENDIE DE LA CARGAISON  
À BORD DU PORTE-CONTENEURS CMA CGM ROSSINI  
LE 15 JUIN 2016, DANS LE PORT DE COLOMBO (SRI LANKA)**

**FIRE OF THE CARGO  
ABOARD THE CONTAINER SHIP CMA CGM ROSSINI  
ON 15 JUNE 2016, IN THE PORT OF COLOMBO (SRI LANKA)**

Rapport publié : mars 2017

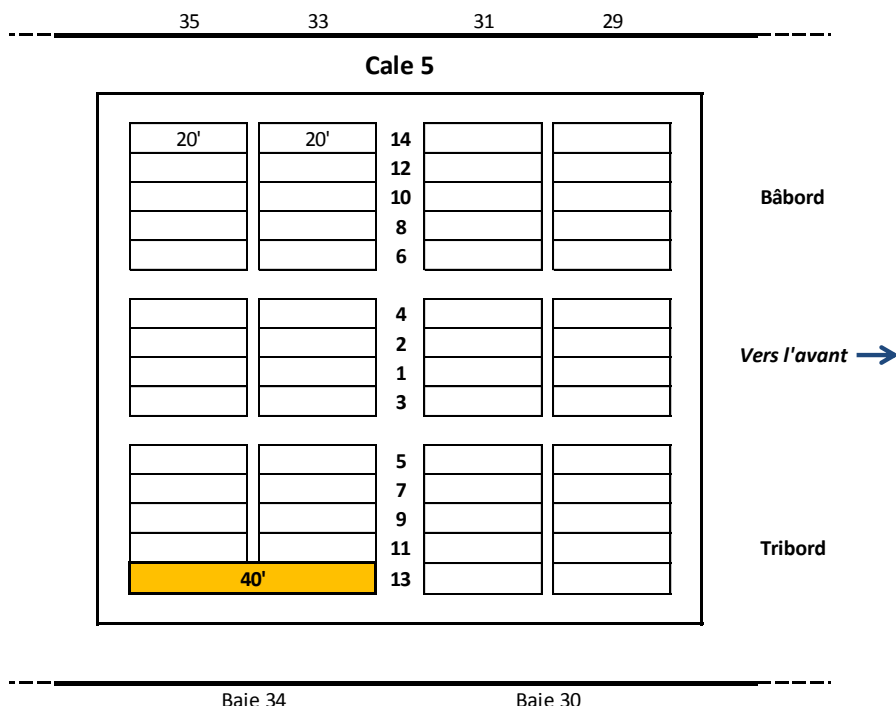
Schéma de la cale 5, vue de dessus :

La baie 34 (numérotation paire pour les conteneurs de 40 pieds) est constituée des baies 33 et 35 (numérotation impaire pour les conteneurs de 20 pieds). Les deux conteneurs sont posés sur

un bottom tank, aux plans 04 et 06 de la pile 13. C'est le conteneur du plan inférieur (04) qui est à l'origine de l'incendie. L'explosion du conteneur du plan 04 a propagé l'incendie à celui du plan 06.

Les conteneurs les plus proches sont situés aux piles 5 et 7, vers le centre de la cale.

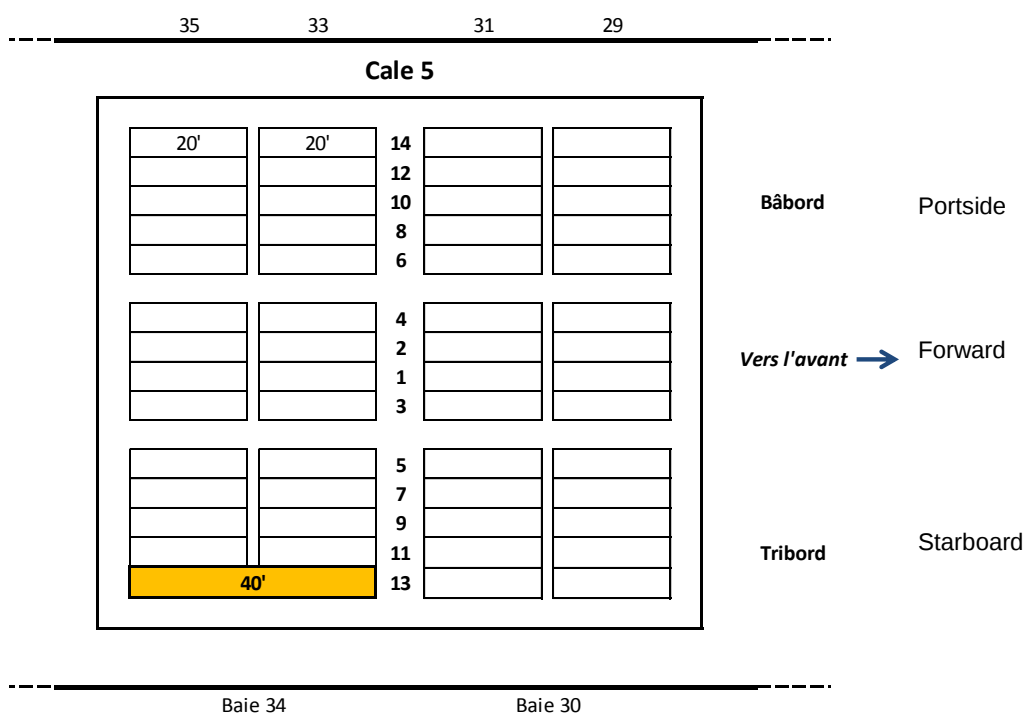
Diagram of hold 5, top view:

Bay 34 (even numbers for 40 foot containers) was made of bay 33 and 35 (odd number for 20 foot containers). Both containers were laying on a bottom tank, at tiers 04 and 06 of row 13. The source of the fire was in the container on the lower tier (04). The explosion of tier 04 container spread fire to tier 06 container.

Closest containers were located at row 5 and 7, toward the centre of the hold.

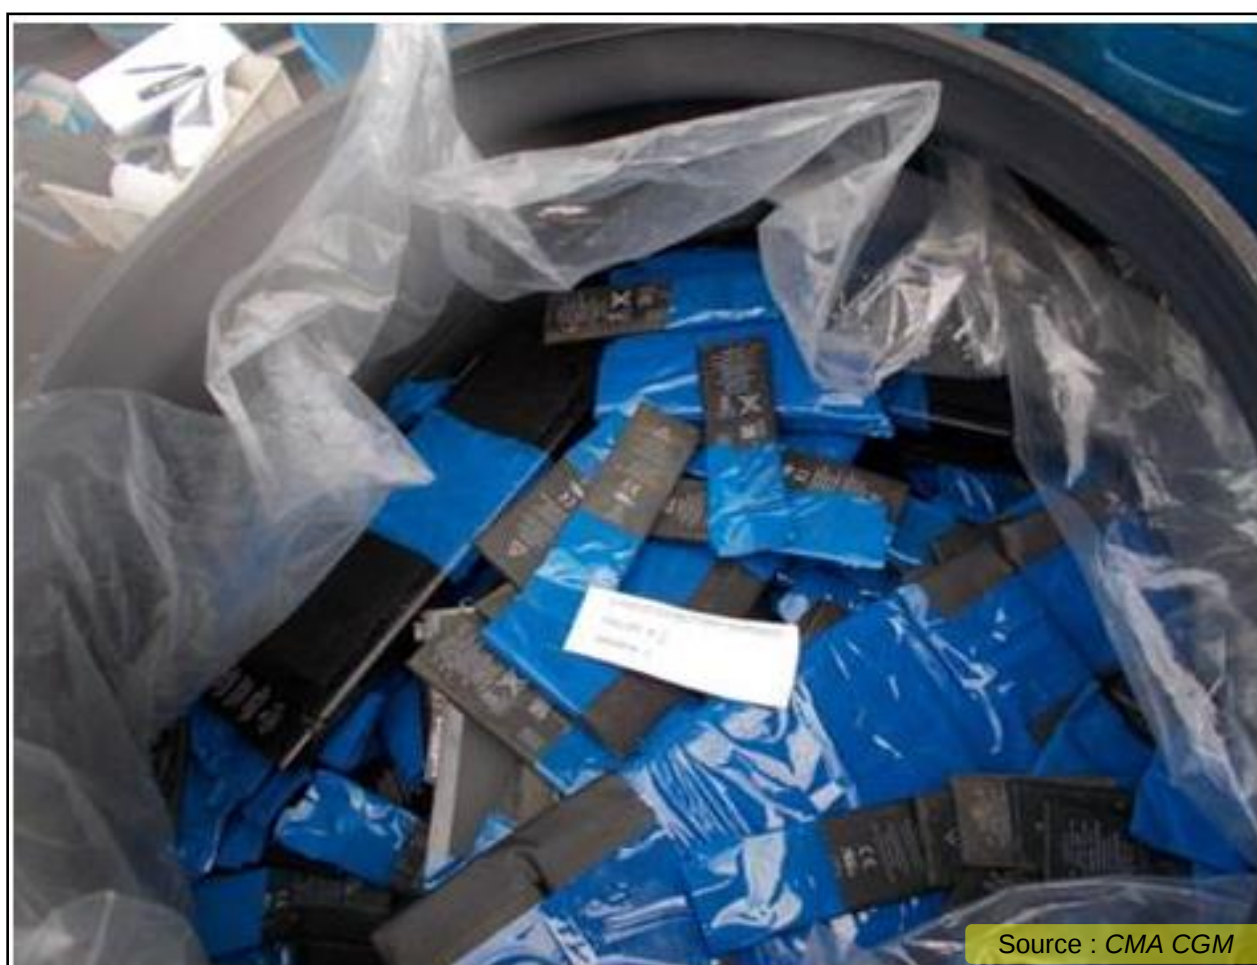
### Appendix C1

Conditionnement : chargement par fûts des batteries (cf. photo en annexe.C1) : les connexions des batteries sont entourées de ruban adhésif. Les batteries sont chargées en vrac dans un sac plastique à la dimension de chaque fût, les fûts étant chargés sur des palettes. Les palettes sont chargées dans les conteneurs.

Chargement de batteries usagées en fûts

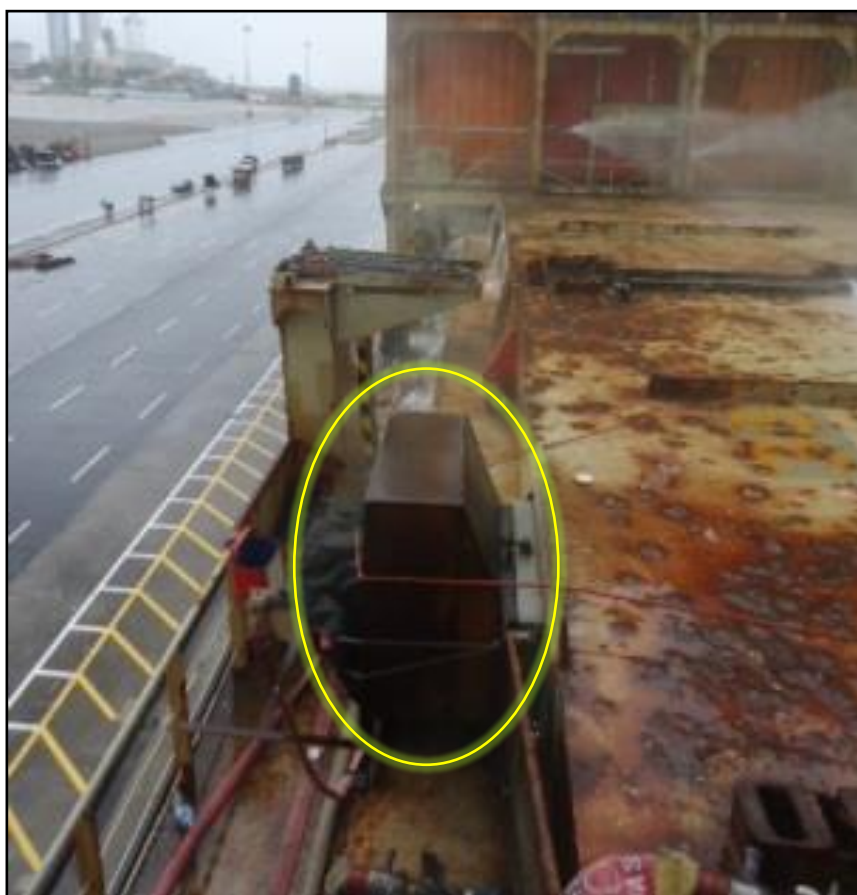
Confection d'un adaptateur (cf. annexe C2) pour raccorder le système de mousse à haut foisonnement du port à la cale du navire.

Adaptateur sur  
ventilation cale pour  
injection mousse

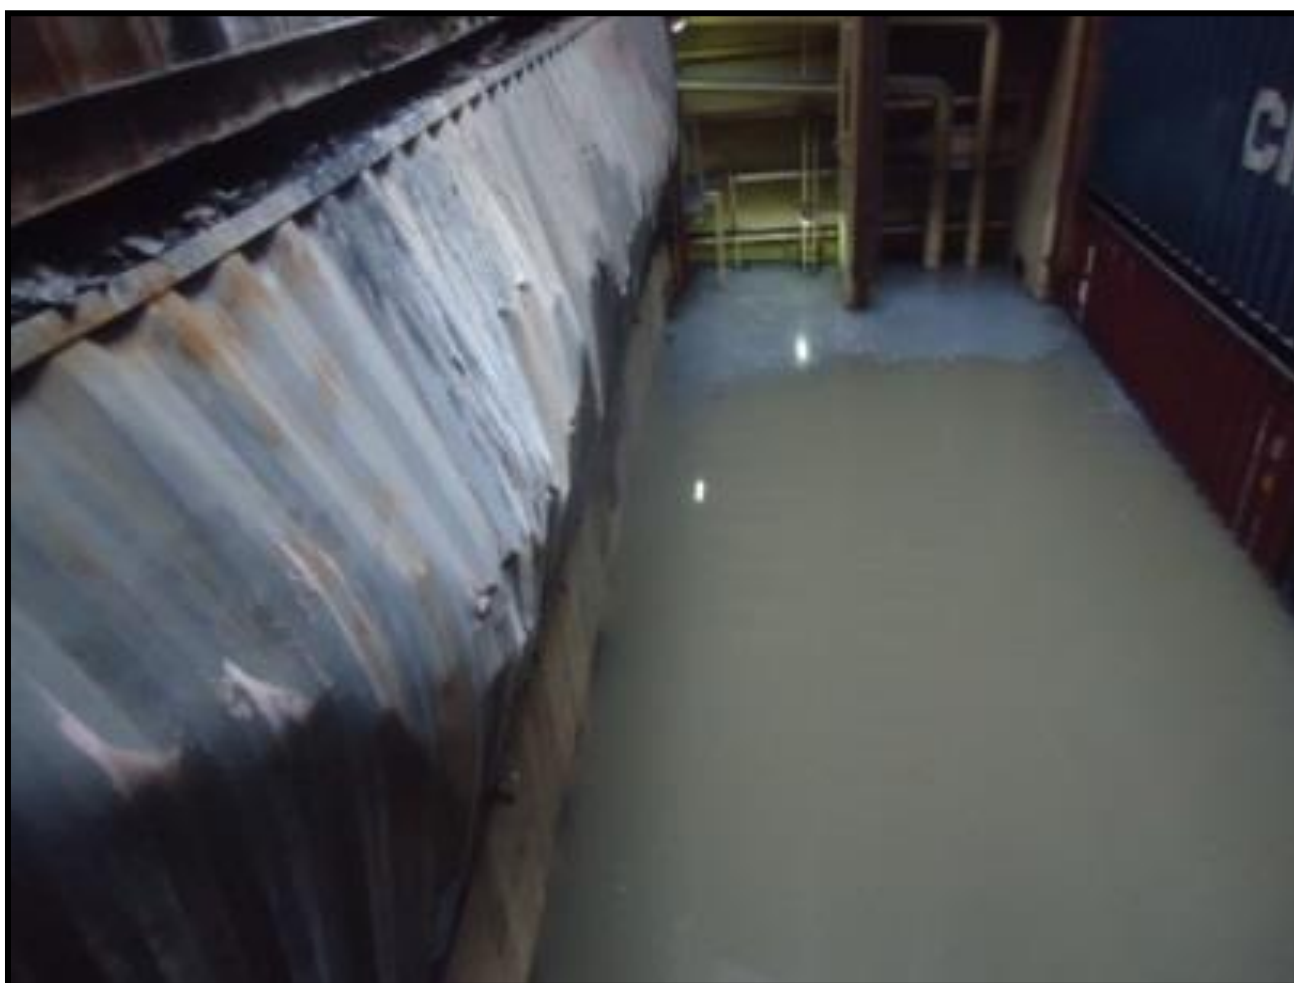
## **Annexe C3**

À **12h30**, retour et rapport des deux équipes de pompiers : aucun feu n'a été observé. La cale 5 contient une hauteur d'eau d'environ 1,50 mètre et l'atmosphère est respirable (cf. annexe C3).

Cale 5 / Source : CMA CGM
