# Rapport d'enquête technique Marine investigation report

**INCENDIE DE LA CARGAISON  
À BORD DU PORTE-CONTENEURS CMA CGM ROSSINI  
LE 15 JUIN 2016, DANS LE PORT DE COLOMBO (SRI LANKA)**

**FIRE OF THE CARGO  
ABOARD THE CONTAINER SHIP CMA CGM ROSSINI  
ON 15 JUNE 2016, IN THE PORT OF COLOMBO (SRI LANKA)**

Rapport publié : mars 2017

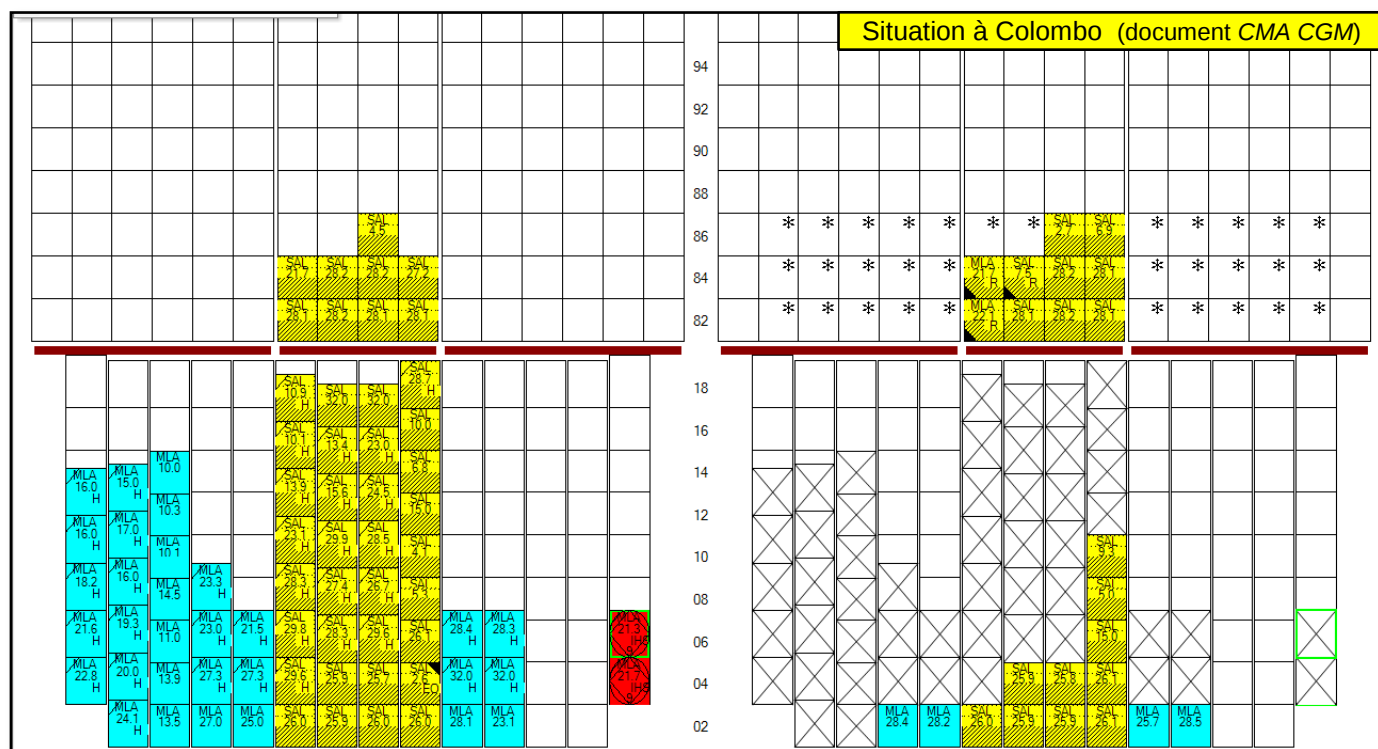
un bottom tank, aux plans 04 et 06 de la pile 13. C'est le conteneur du plan inférieur (04) qui est à l'origine de l'incendie. L'explosion du conteneur du plan 04 a propagé l'incendie à celui du plan 06.

Les conteneurs les plus proches sont situés aux piles 5 et 7, vers le centre de la cale.

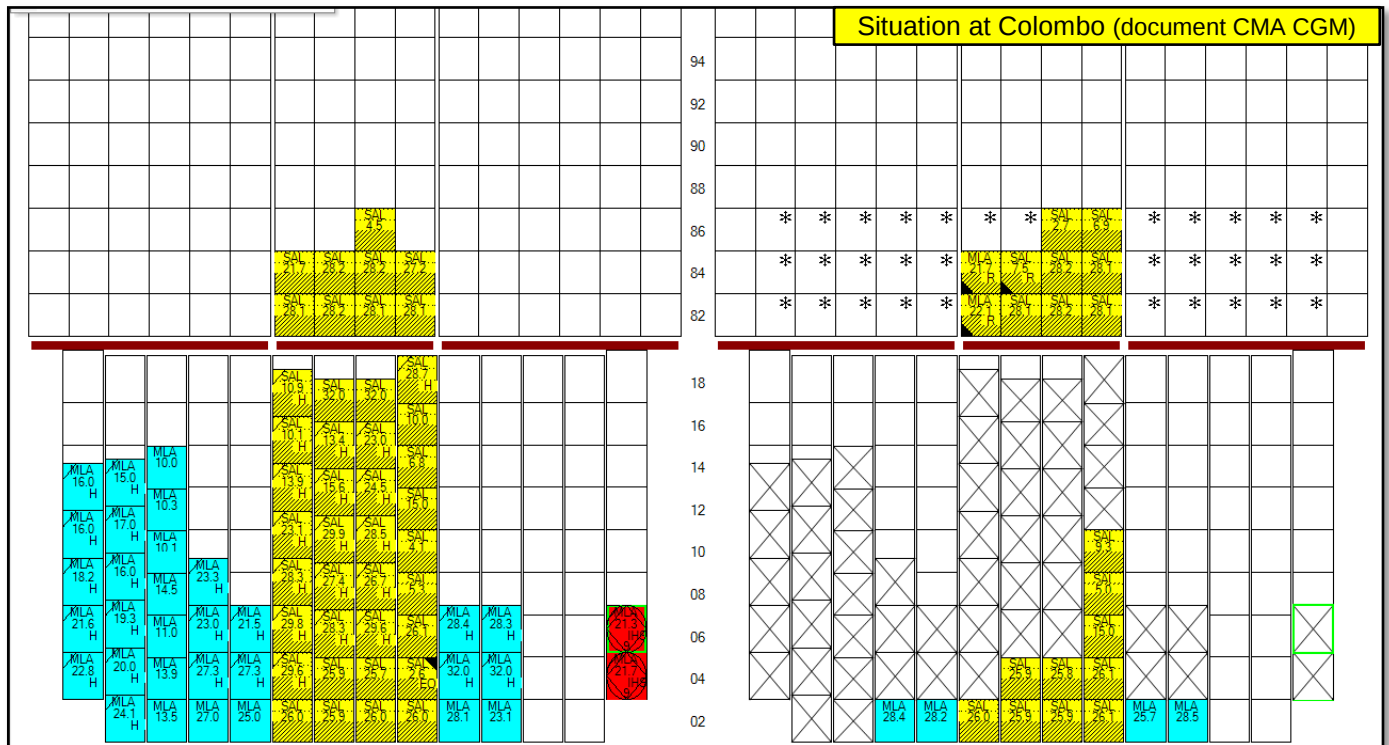
Bay 34 (even numbers for 40 foot containers) was made of bay 33 and 35 (odd number for 20 foot containers). Both containers were laying on a bottom tank, at tiers 04 and 06 of row 13. The source of the fire was in the container on the lower tier (04). The explosion of tier 04 container spread fire to tier 06 container.

Closest containers were located at row 5 and 7, toward the centre of the hold.

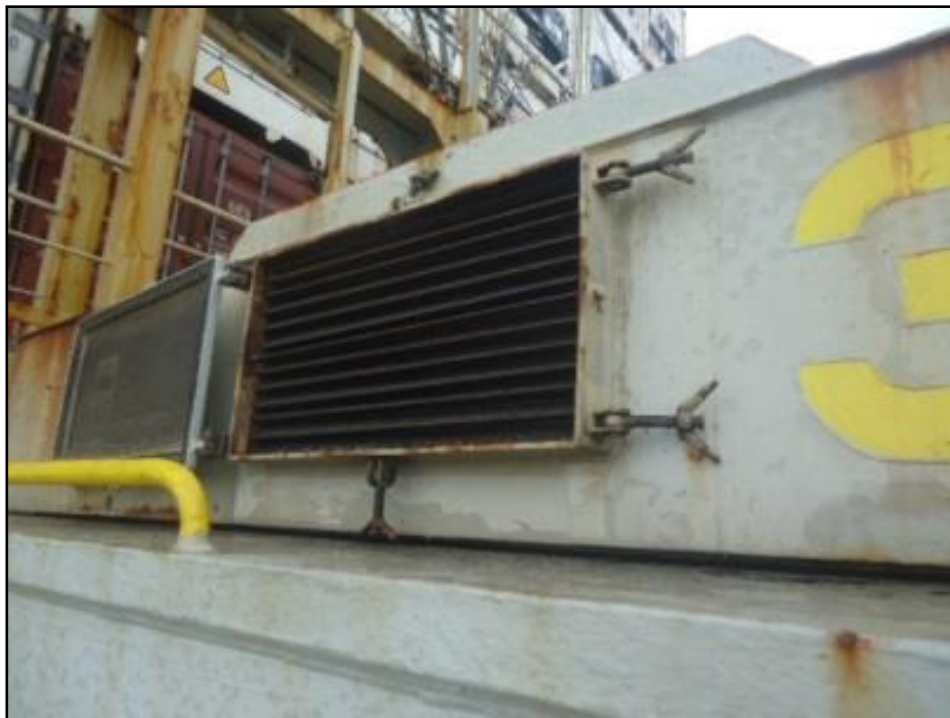
Ventilation cale

Adaptateur sur  
ventilation cale pour  
injection mousse
